Accelerator Operations Summary

R. Dixon

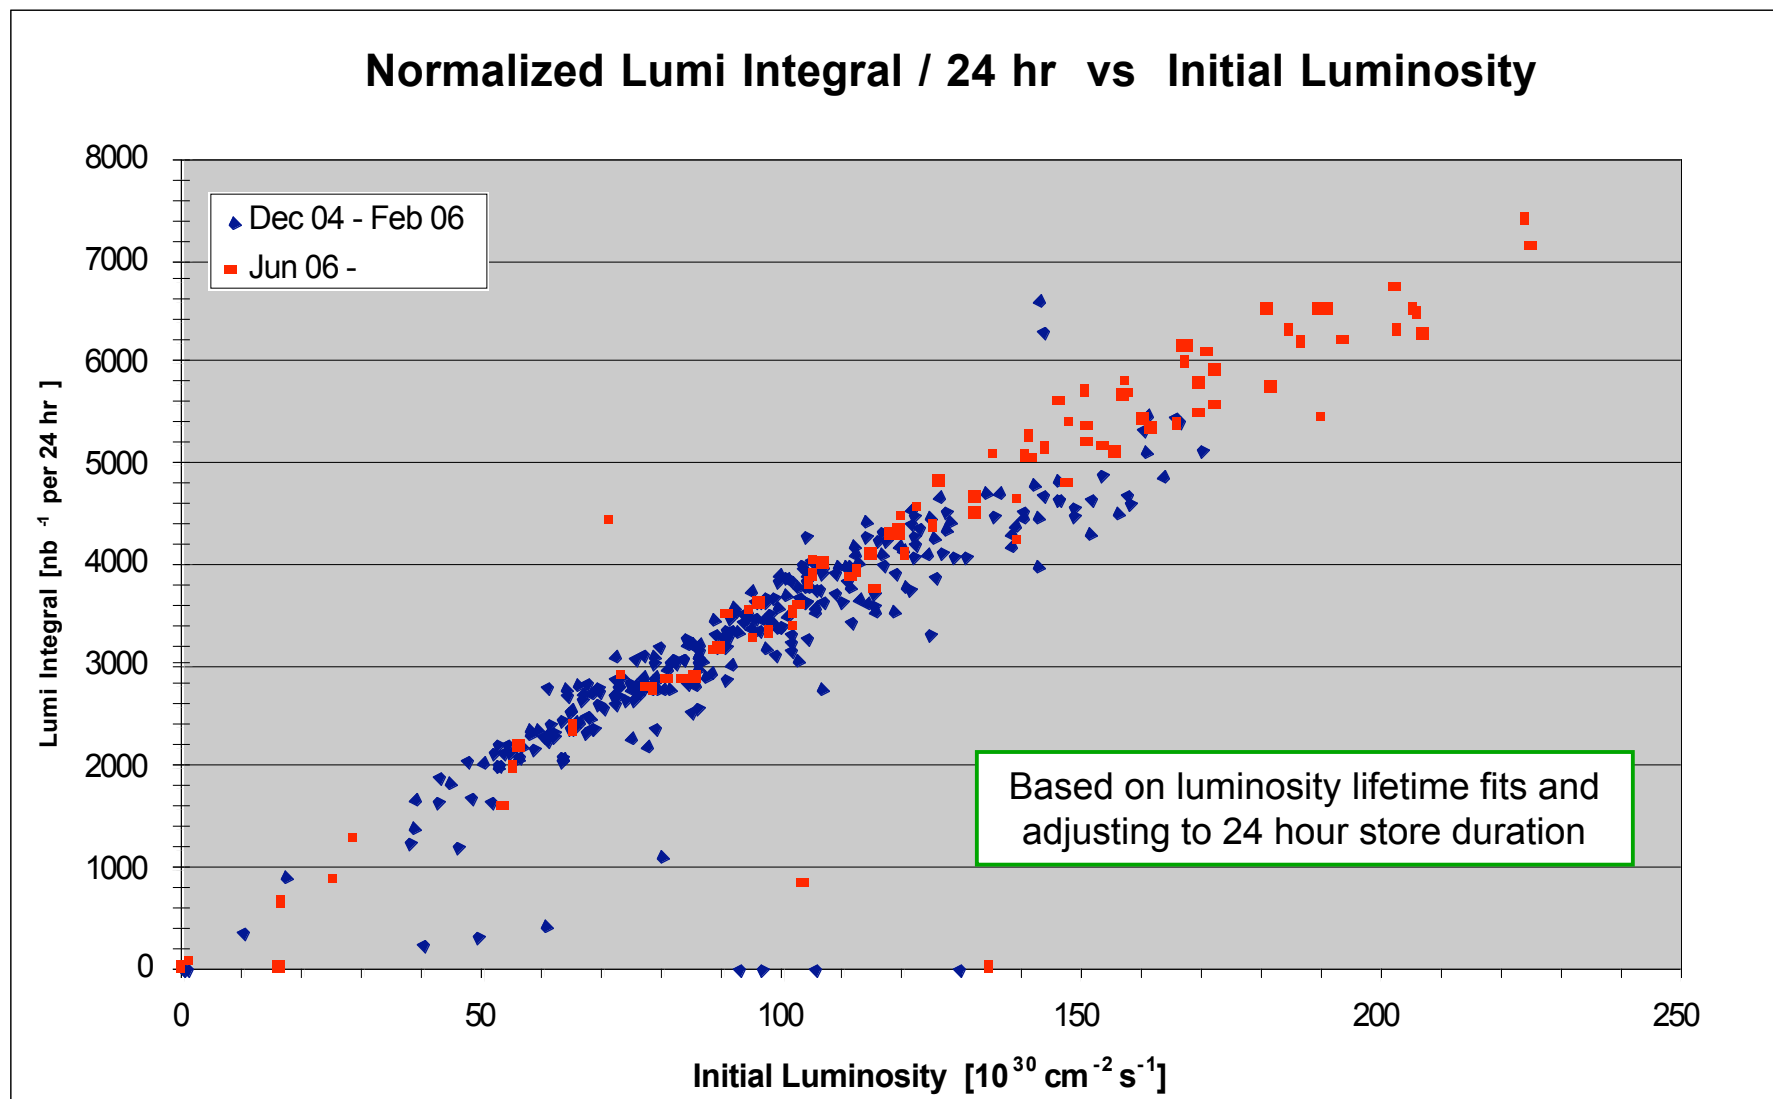
Better Lifetime \Rightarrow More Delivered Luminosity

- $\sim 20\%$ increase @ upstream IP
 - Not as much @ downstream IP
- Luminosity lifetime improved $\sim 20\%$ compared to pre-shutdown running
 - Increased integrated luminosity per store (for given store length)

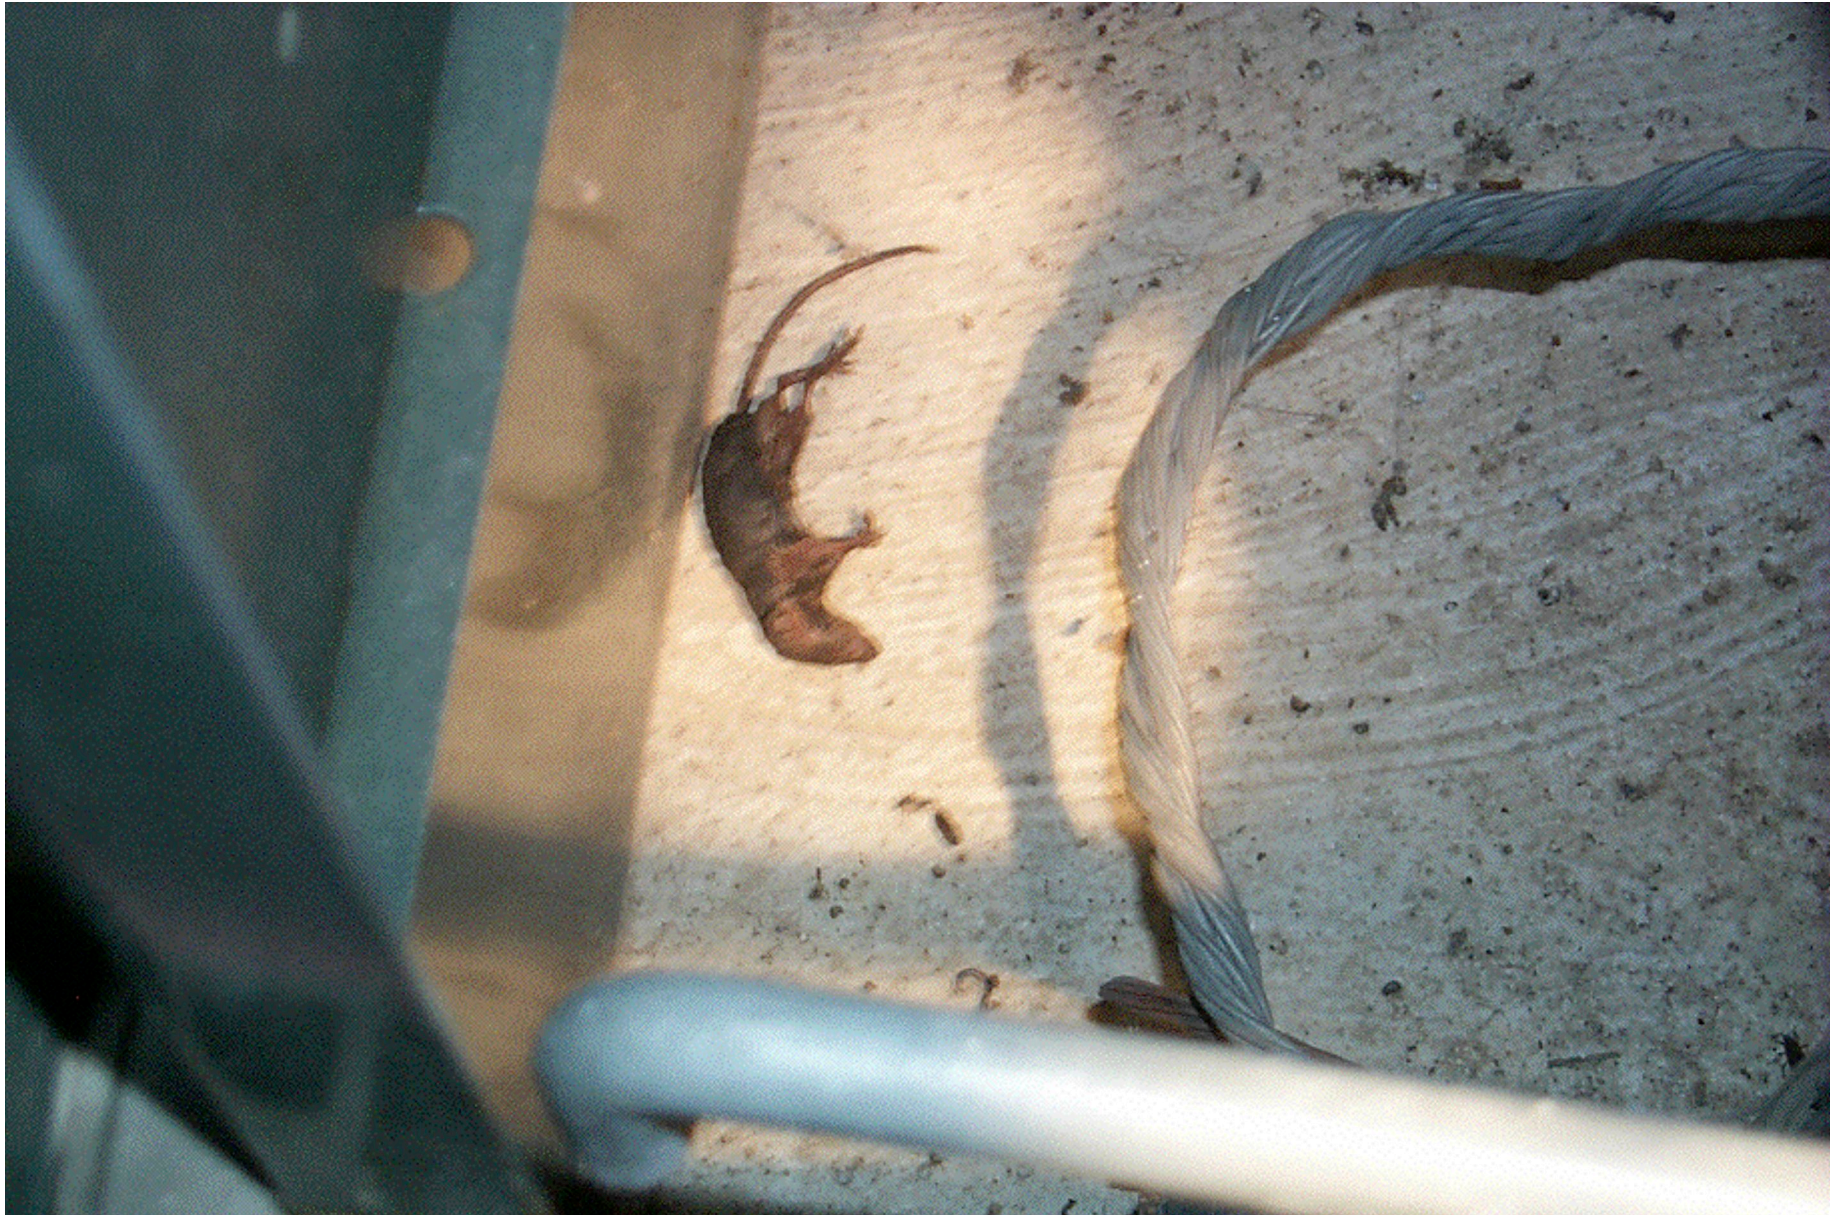
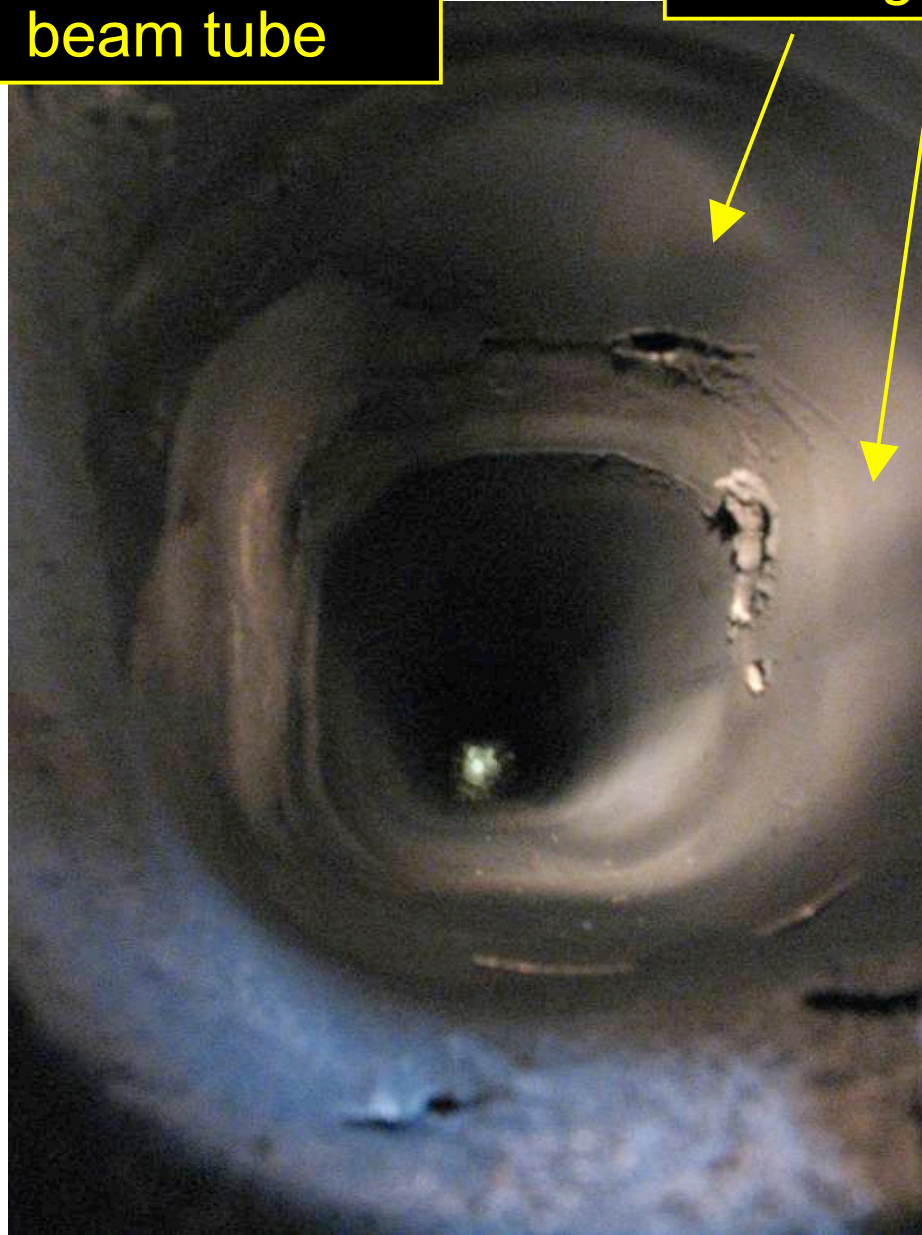
The Culprit

D32-5 dipole
beam tube

*Holes from
arcing?*

- HEP store 5008 happily spinning
 - Record # pbars injected into Tev, record # pbars reach HEP start
- Mouse seeks Feeder 46B cubicle as possible new, cozy home
 - Flashover + resulting nasty power glitch affects many systems
 - Many UPS units switched over
- Tevatron ramp begins to dump on A2 power supply trip
 - Beams aborted cleanly
- 1.2 sec into ramp dump, D3 QPM reboots (Quench Protection Monitor)
 - Why? Glitch not filtered out by UPS? UPS tested fine later...
 - As designed, QPM fired heaters, generating whole-house quench
- ≈4 sec into ramp dump, ground fault developed in D3
 - D32-5 dipole failed

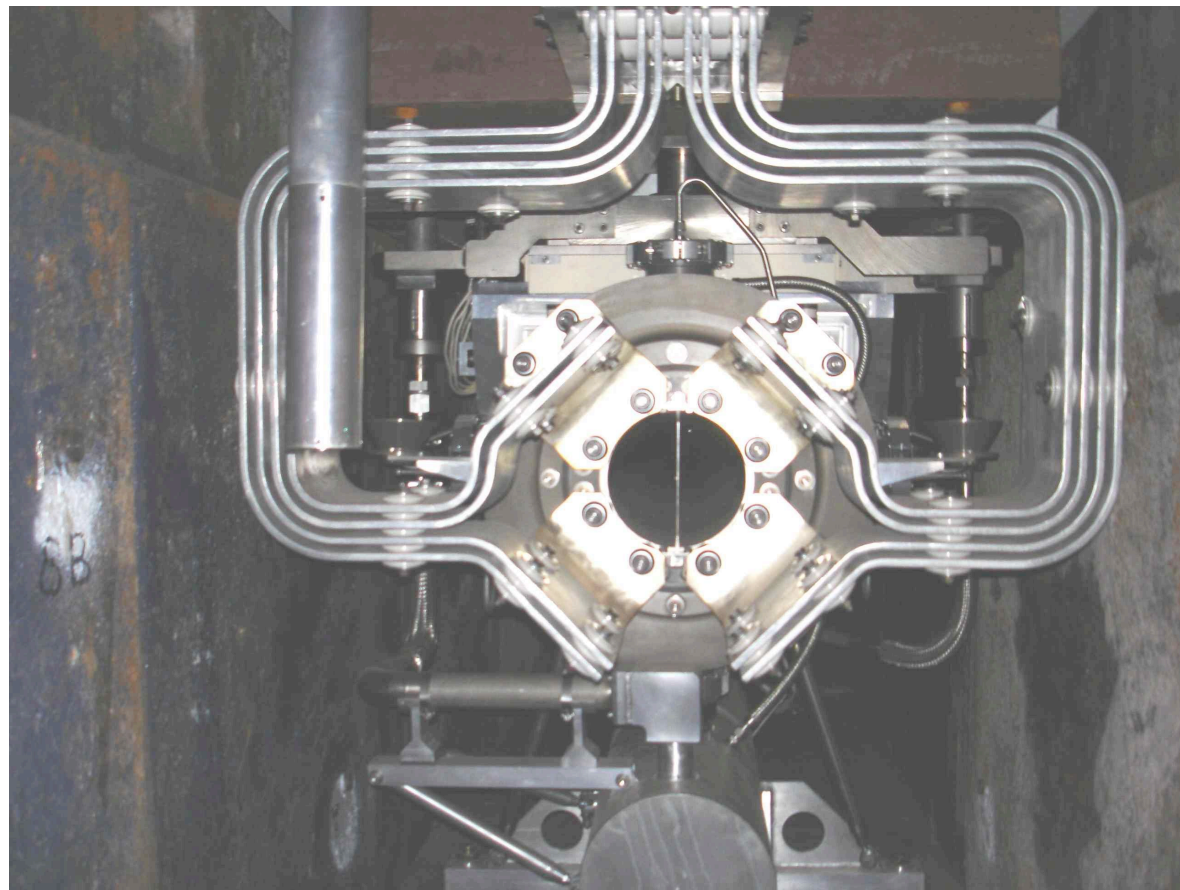
Horns were
put in
target hall
June 2004

1st run with
beam
Jan. 2005

Accumulated:

9.2 Million
pulses

820 MWhr
integrated beam power

Still running with first set of horns

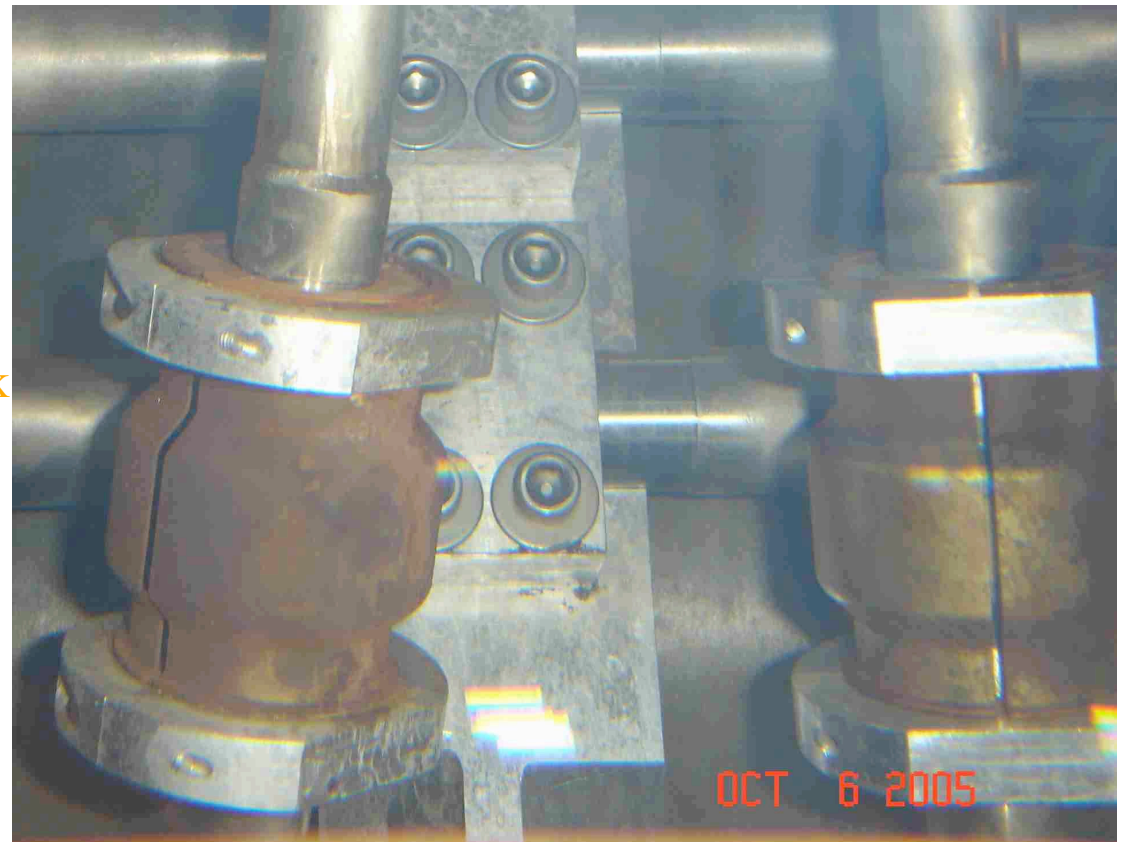
Two horn water system leaks

Horn 2 in February 2006, Horn 1 in August 2006

Have brazed ceramic electrical insulators on horn water lines
They are strain-relieved with invar+ceramic clam-shells

On horn 1, developed a 7gal/day
water leak on line to spray header

On horn 2, leak on suction line
drew air in, reducing amount
of water ejector pump could
remove from horn collection tank

Both ceramic sections were
successfully replaced

Speculate braze corrodes...
planning to switch from brazed
to a shrink-fit ceramic/steel
connection for spare horns

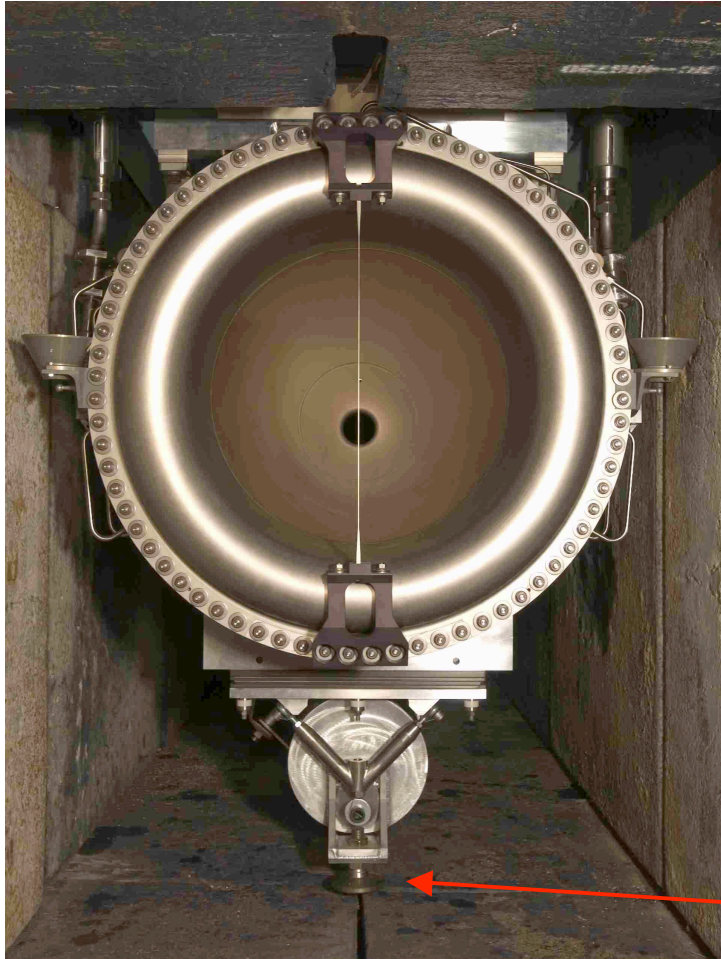
Horn 2 ground fault - - loose foot on horn

Horn 2 before beam
1.5 inch clearance foot to floor

Owl shift Thurs. Sept. 29, 2005 intermittent horn trips.
Owl shift Sat. Oct. 1, hard ground fault of 1 ohm.
*-removing stripline fingers Horn 2 + stripline block
-when Horn 2 moved to work cell ground fault cleared
-foot left behind in chase, nut had vibrated off
-scorch marks seen under foot*

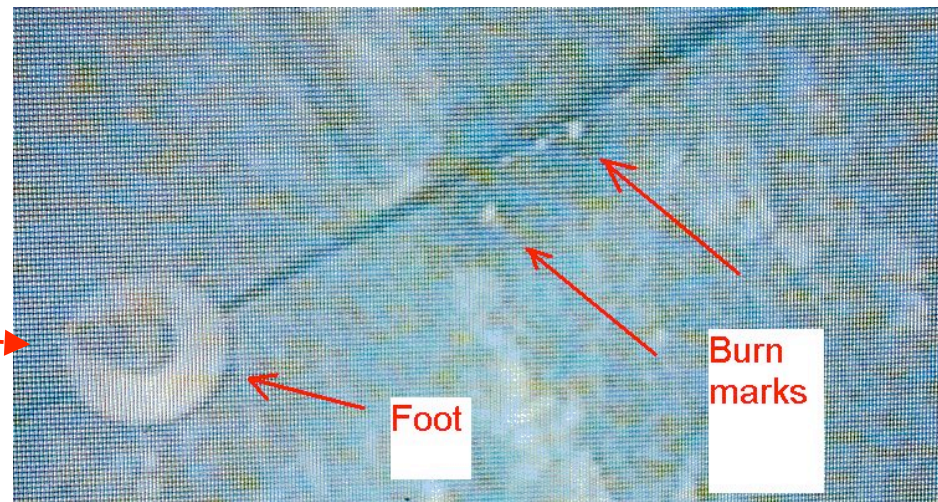
Moved old foot, installed new foot
